ZONING CASE: Z2004-151

City Council District NO. 9
 Requested Zoning Change
 From: RM-4 ERZD To PUD RM-4 ERZD
 Date: August 26, 2004
 Scale: 1" = 300'

Zoning Case Z2004151

Marbella Village

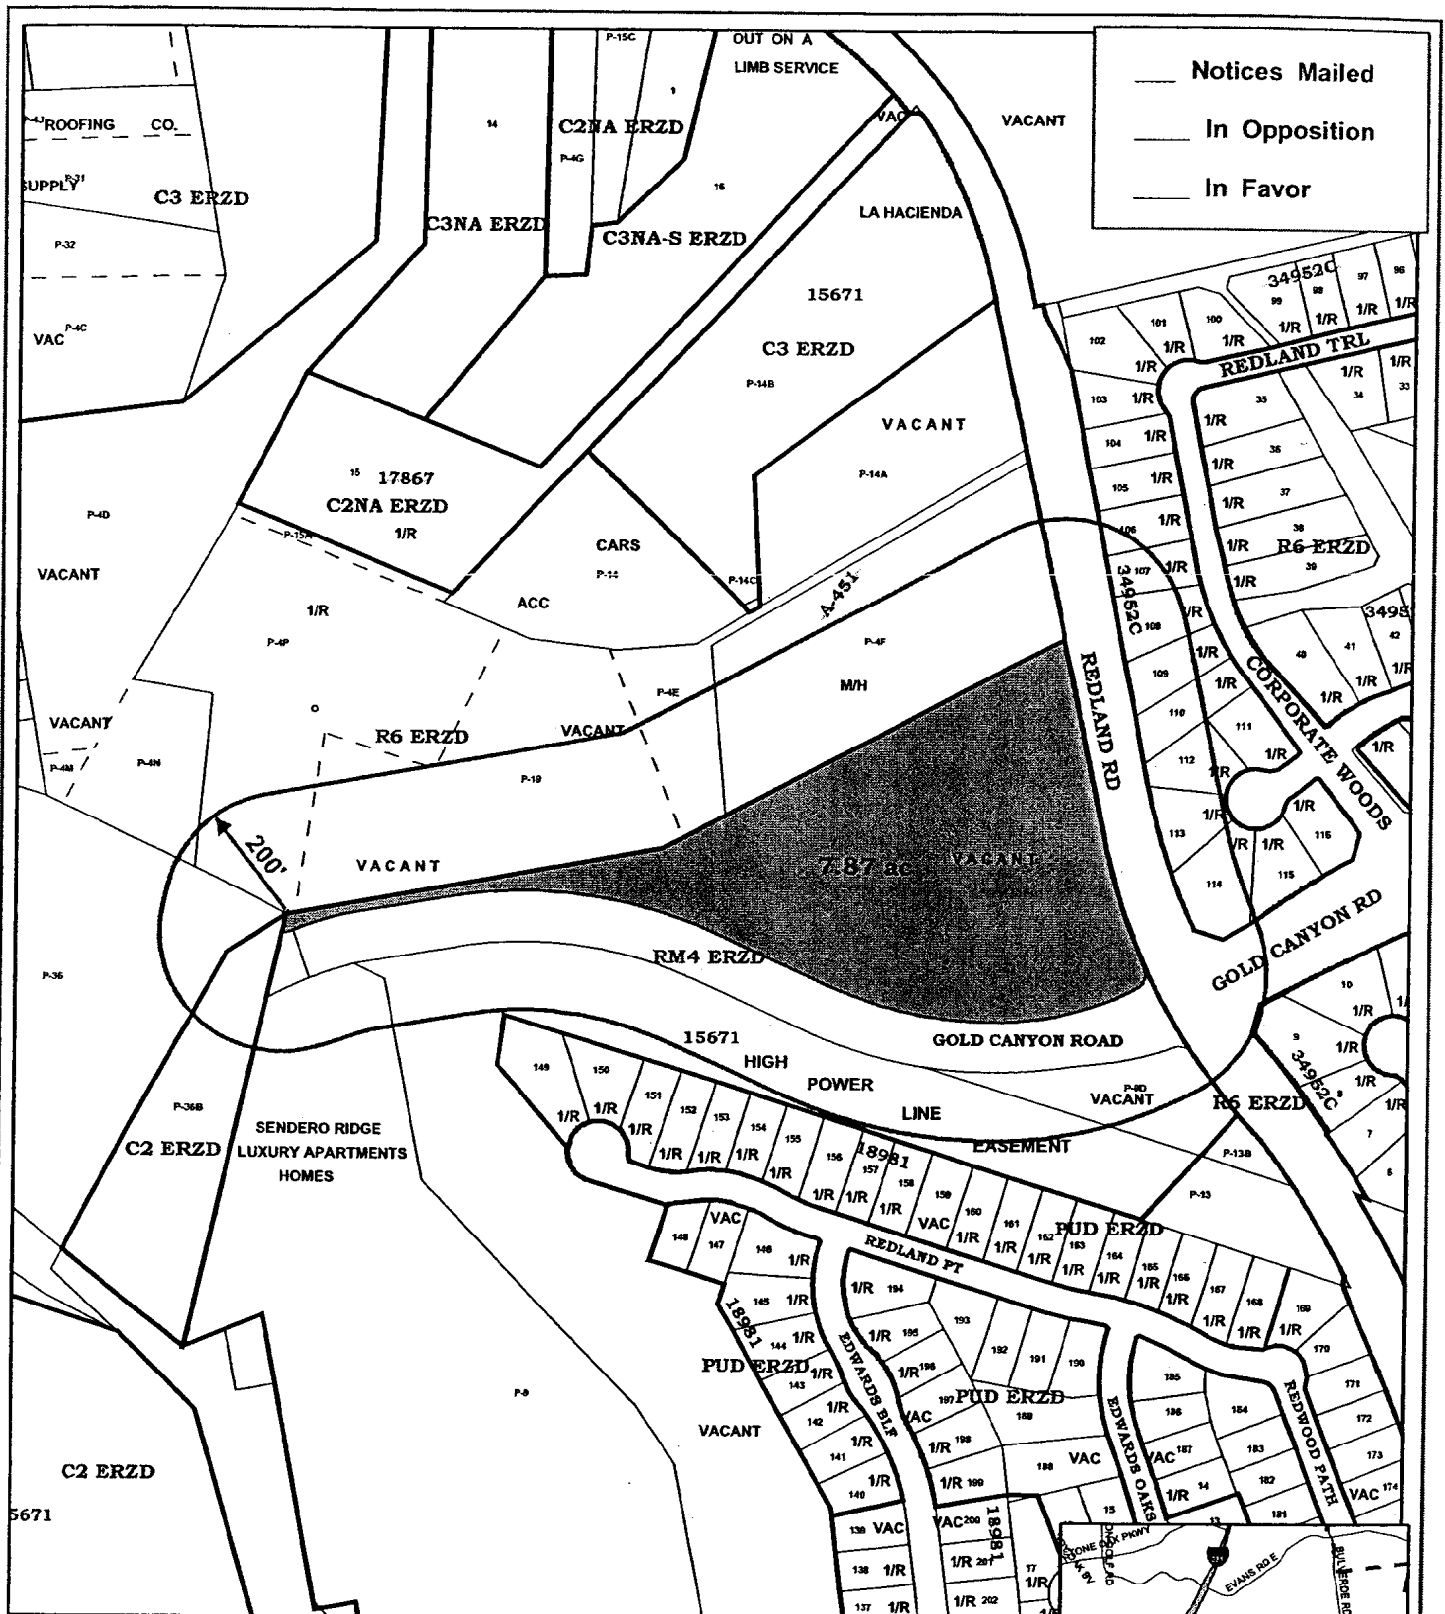
■ Subject Property

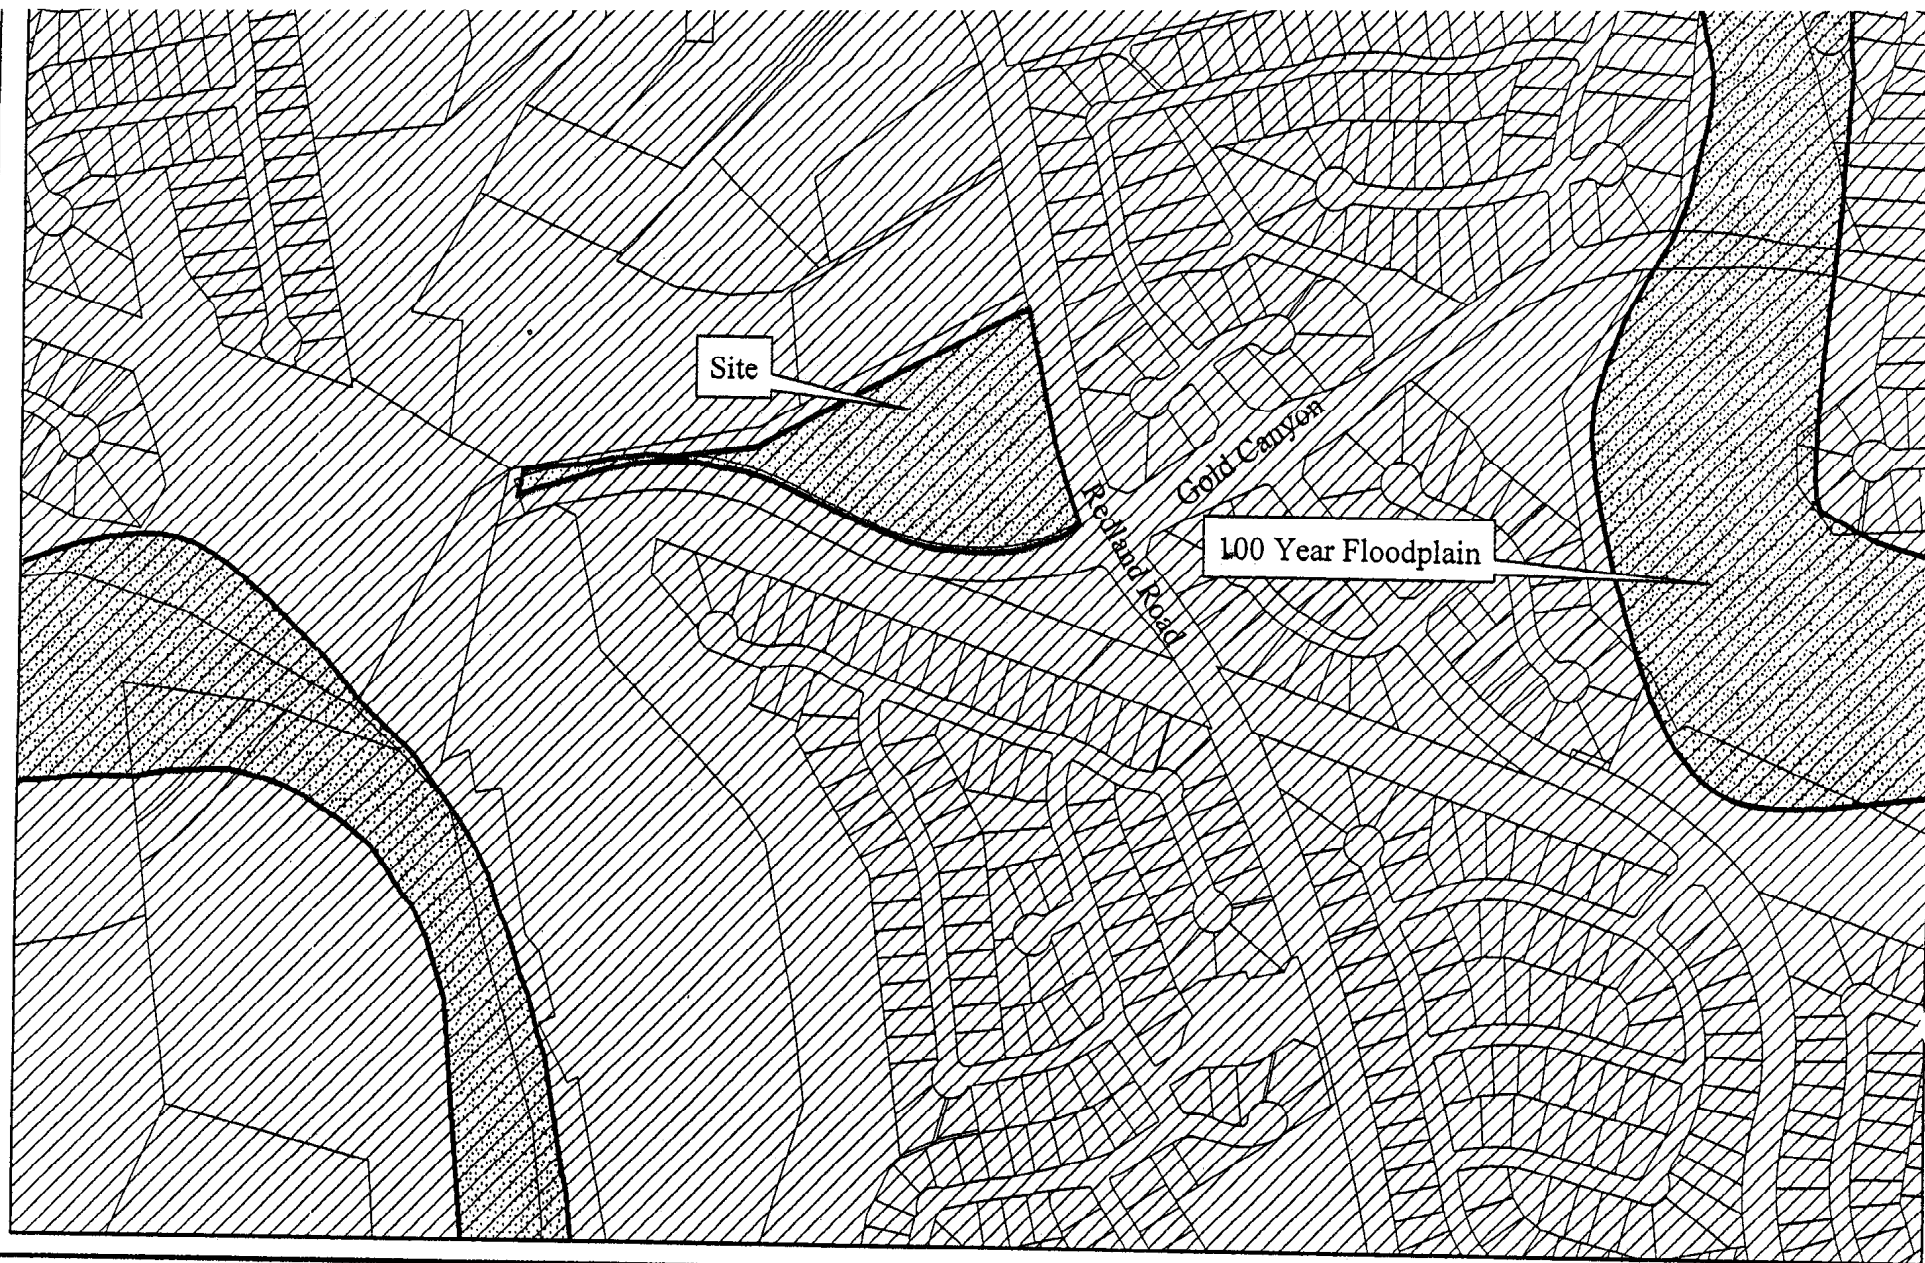
Zoning Case Z2004151 Figure 2

Marbella Village

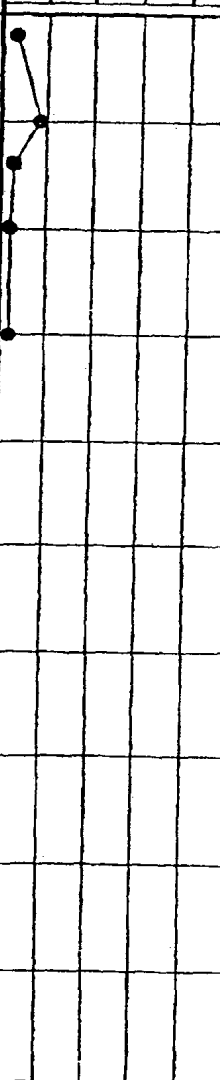
PROJECT NAME

Preliminary Soil Survey
7.91 Acre Tract
At the NW Corner of
Redland and Gold Canyon Road Intersection
San Antonio, Texas

SS	Very Stiff to Hard Dark Brown Clay			80/8"		58	40

SS	- With Limestone Fragments			50/6"		52	35	
		SS	Hard Light Tan Limestone			50/2"				
		SS	- With Tan Calcareous Clay Seam at 7'							
		SS								
10		AU								
15		SS				50/3"				
20										
25										
30										
35										
40										
45										
50

Completion Depth 15'	Ground Water Observed No	Date: 5/25/2004
S.S. by P.P.- Shear Strength in TSF by Hand Penetrometer	S.S.- Split Spoon Sample S.T.- Shelby Tube Sample AU- Auger Sample	L.L.- Liquid Limit P.L.- Plastic Limit M.C.- Moisture Content Plate: 3

In addition, Integrated Testing and Engineering Company provided a preliminary soil and foundation engineering report (Attachment 4). A total of 5 borings were drilled to depths of 15 feet. Uniform hard, light-tan limestone was encountered at depths ranging from 2-5 feet. Voids were not noted in the boring logs, nor was groundwater observed.
