# **ZONING CASE: Z2004-265**

From: "R-6 ERZD" To "C-3NA ERZD"

**Subject:** Zoning Case Z2004265 (4 acre Office\Warehouse)

A request for a change in zoning has been made for an approximate 4-acre tract located on the city's north side. A change in zoning from "R-6 ERZD" to "C-3 NA ERZD" is being requested by the applicant, Randy Schumacher. The change in zoning has been requested to allow for the development of an office and warehouse complex.

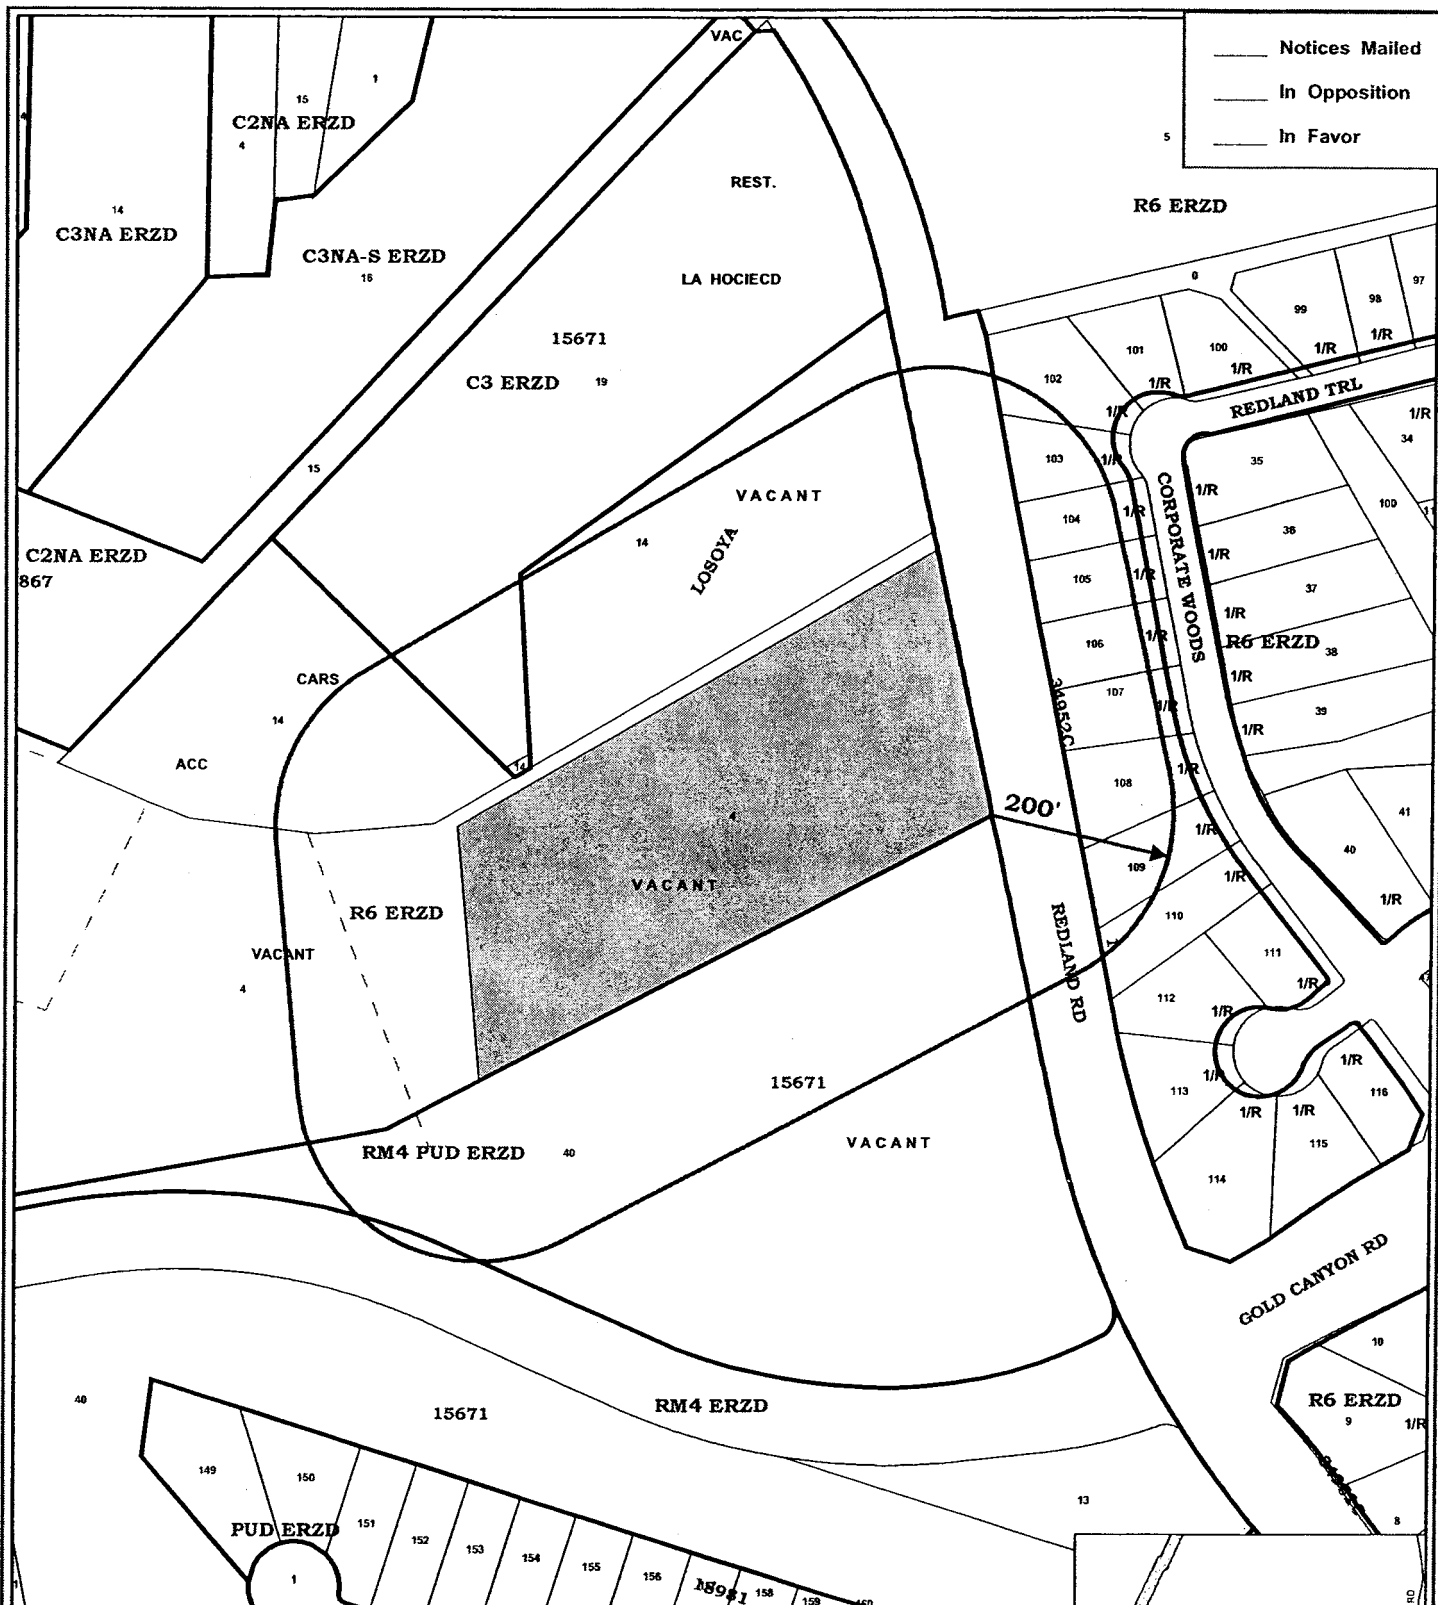
Requested Zoning Change

Scale: 1" = 200'

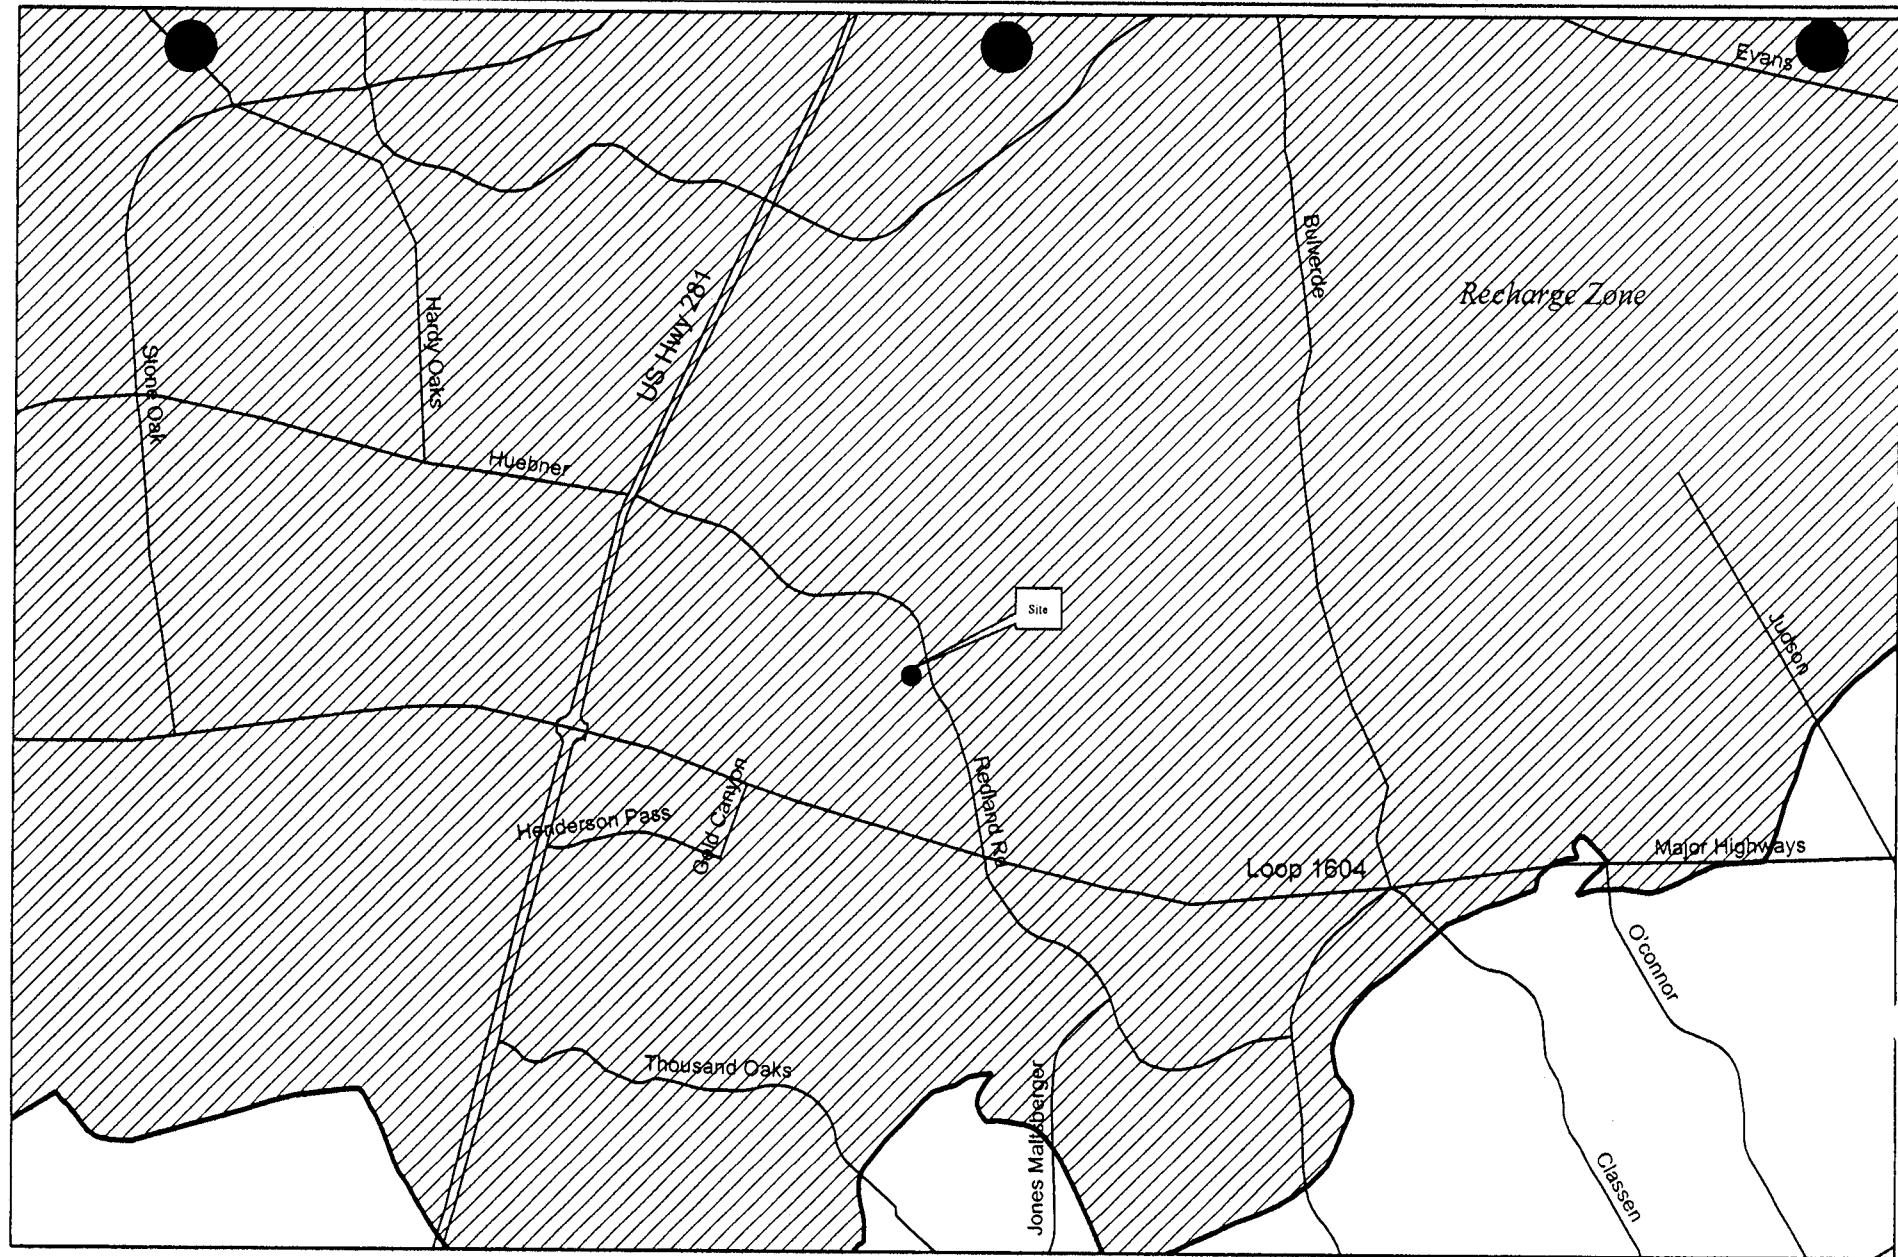
# **Zoning Case Z2004265 Figure 1**

4 acre Office/Warehouse

1:44,569

The subject property is located in City Council District 9, along the west side of Redland Road, north of Gold Canyon. The property lies within the Edwards Aquifer Recharge Zone (Figures 1 and 2).

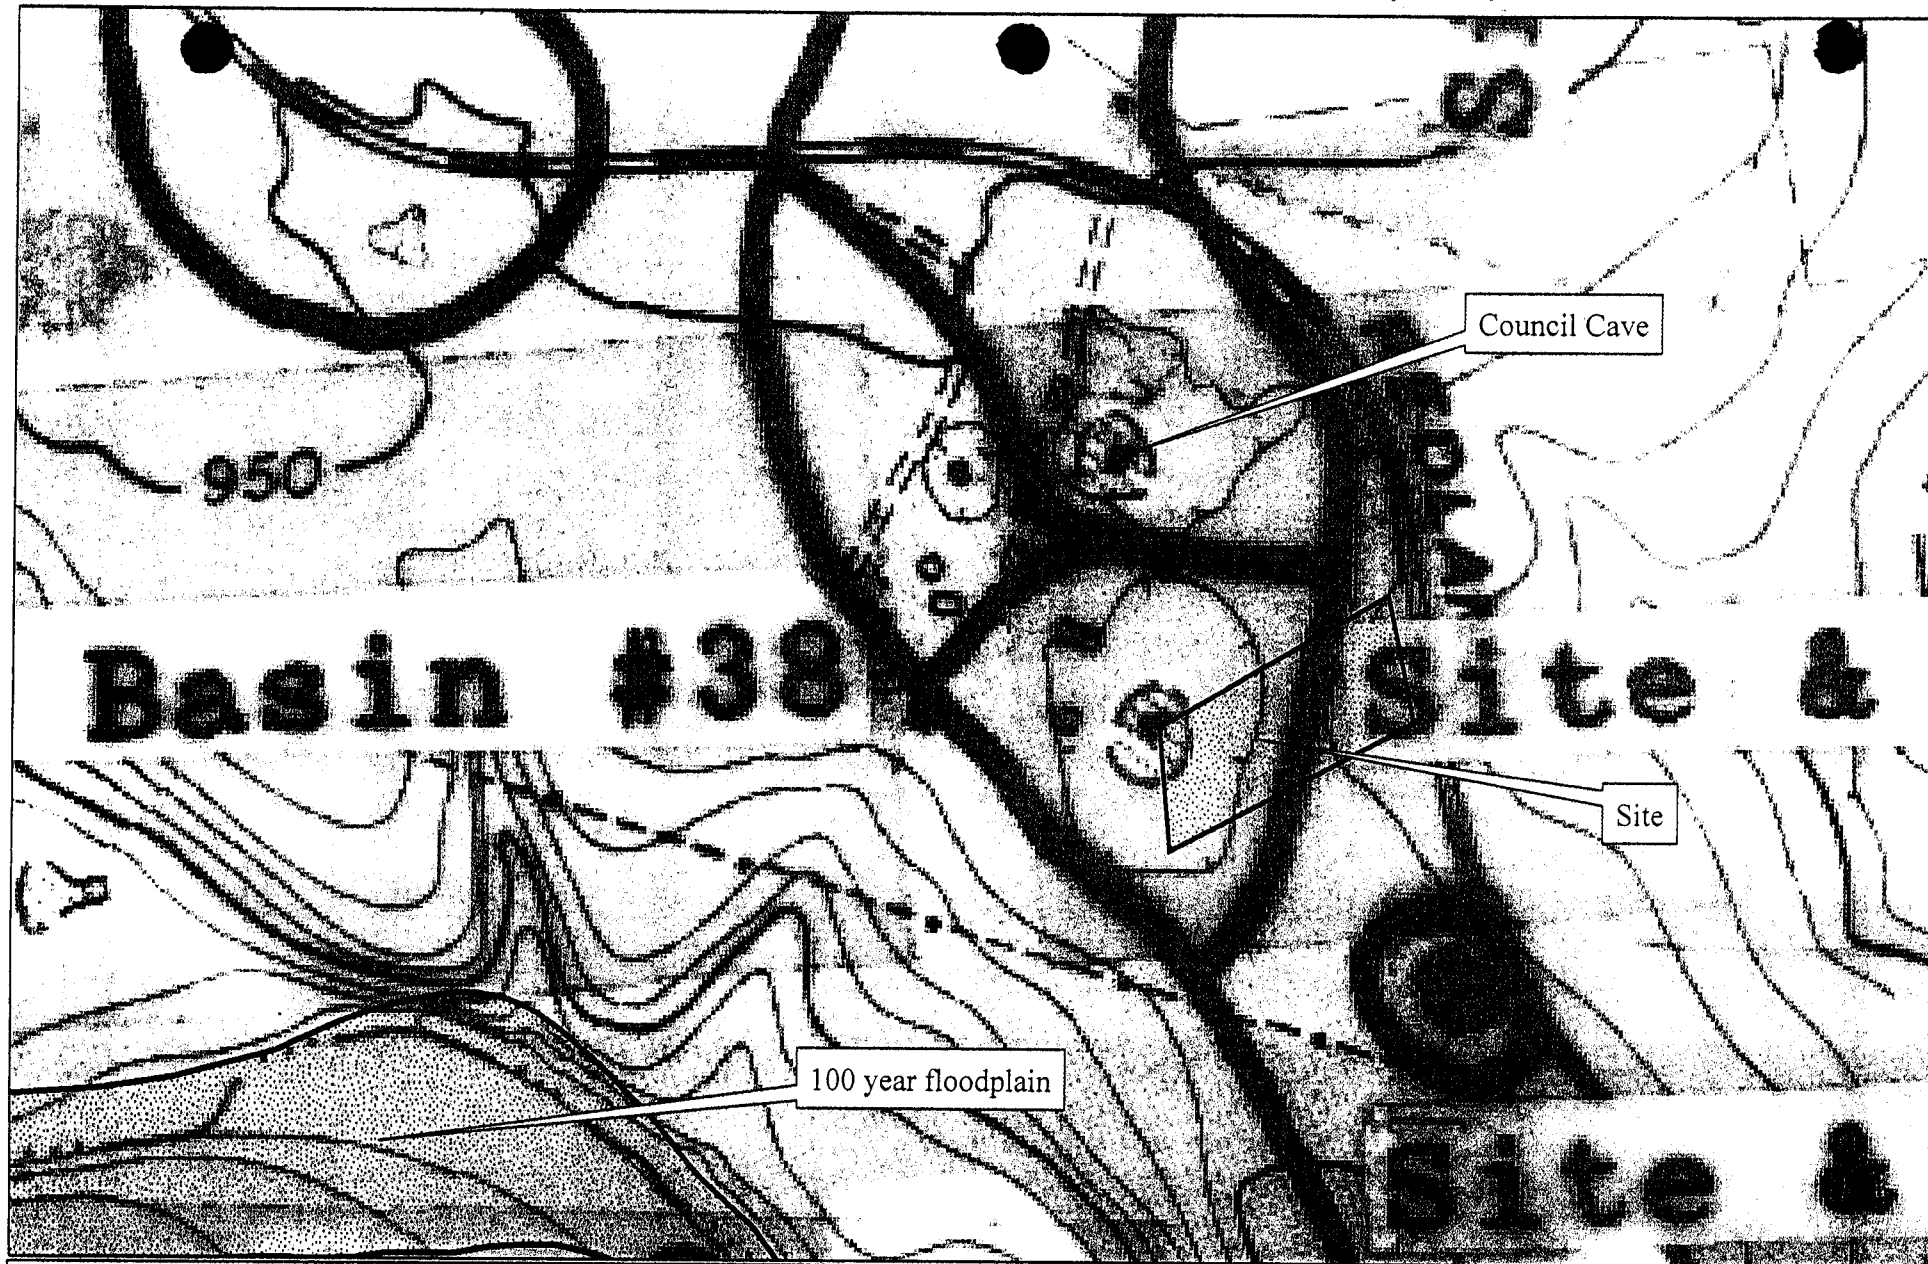
Veni's Feature Map (Longhorn Quad)

Zoning Case Z2004265

1:5,129

In *Significant Edwards Aquifer Karst Recharge Features of Bexar County, Texas 1989*, a report prepared by George Veni for the city of San Antonio, it states that the drainage area for the cave is approximately 22.04 acres and that the surrounding property is of low gradient. In addition, it states that included in the drainage is runoff from a nearby business via a pipe leading to the sinkhole. This report places the cave within the Longhorn Quadrangle. Additionally, the report notes three sinkholes, Redland Tri-Sinks (Basin 37, 38 and 39), in the area on and adjacent to the subject property. (Attachment 2).
